TALKING TIMBER

TAKING CARE

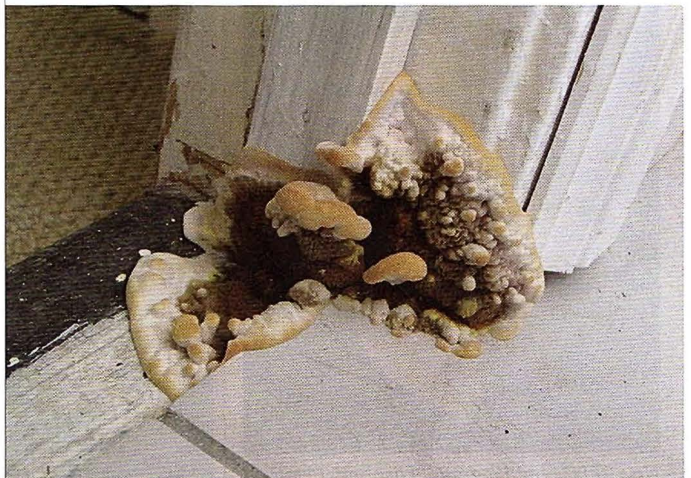
Below: Dry rot affecting timber

When timber is exposed to excessive moisture for prolonged periods the likely result is an attack by one of a number of wood-destroying fungi. Dry rot, *Serpula lacrymans*, is the most serious form of fungal decay of timber – it has the ability to spread into perfectly dry areas causing extensive damage.
